FLOOD PLAIN INFORMATION

LEVEL
NINEMILE CREEK

TOWNS OF MARCELLUS, CAMILLUS AND GEDDES,
ONONDAGA COUNTY, NEW YORK

PREPARED FOR THE NEW YORK STATE DEPARTMENT OF ENVIRONMENTAL CONSERVATION
BY THE DEPARTMENT OF THE ARMY, BUFFALO DISTRICT, CORPS OF ENGINEERS
BUFFALO, NEW YORK OCTOBER 1976

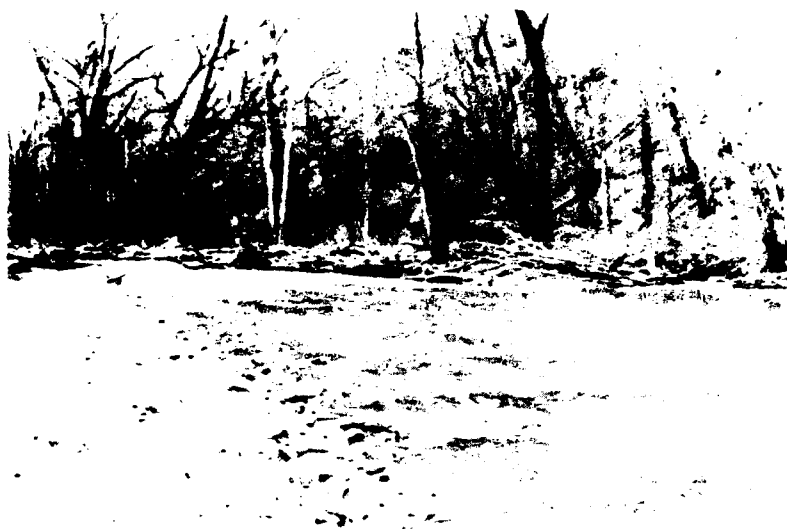
FIGURE 5 - Fallen trees, logs and brush form natural obstructions to floodflows upstream of the Martisco Road bridge at stream mile 10.3. Photo taken April, 1975.

Obstructions to Floodflows - Natural obstructions to floodflows include trees, brush and other vegetation growing along the stream banks in floodway areas. Man-made encroachments on or over the streams such as dams, bridges and culverts can also create more extensive flooding than would otherwise occur. Representative bridges, dams and some obstructions to floodflows are shown in Figures 3 through 9.

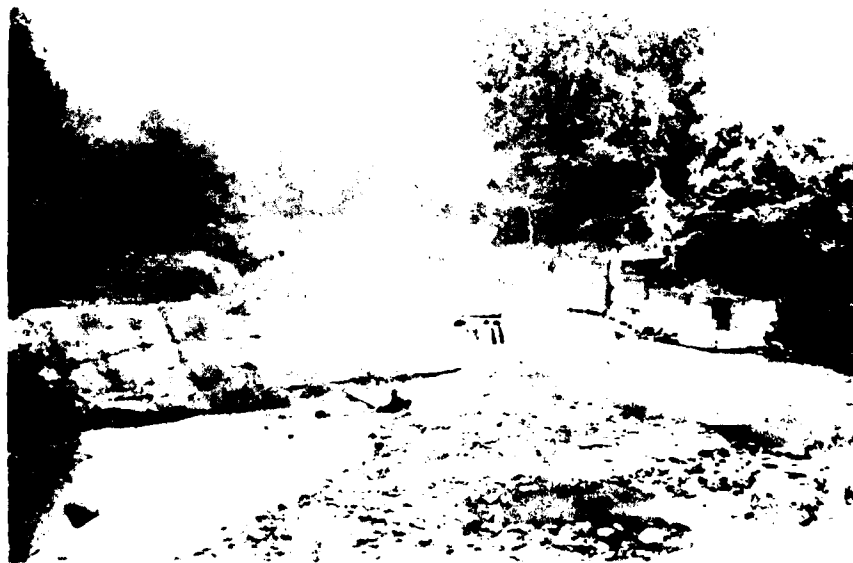
FIGURE 9 - Dam 1 located at stream mile 3.83 near the Warners Rd. bridge at Amboy in Camillus. A portion of the dam has been removed since the 1965 storm to reduce upstream flooding. Photo taken Sep 1969.

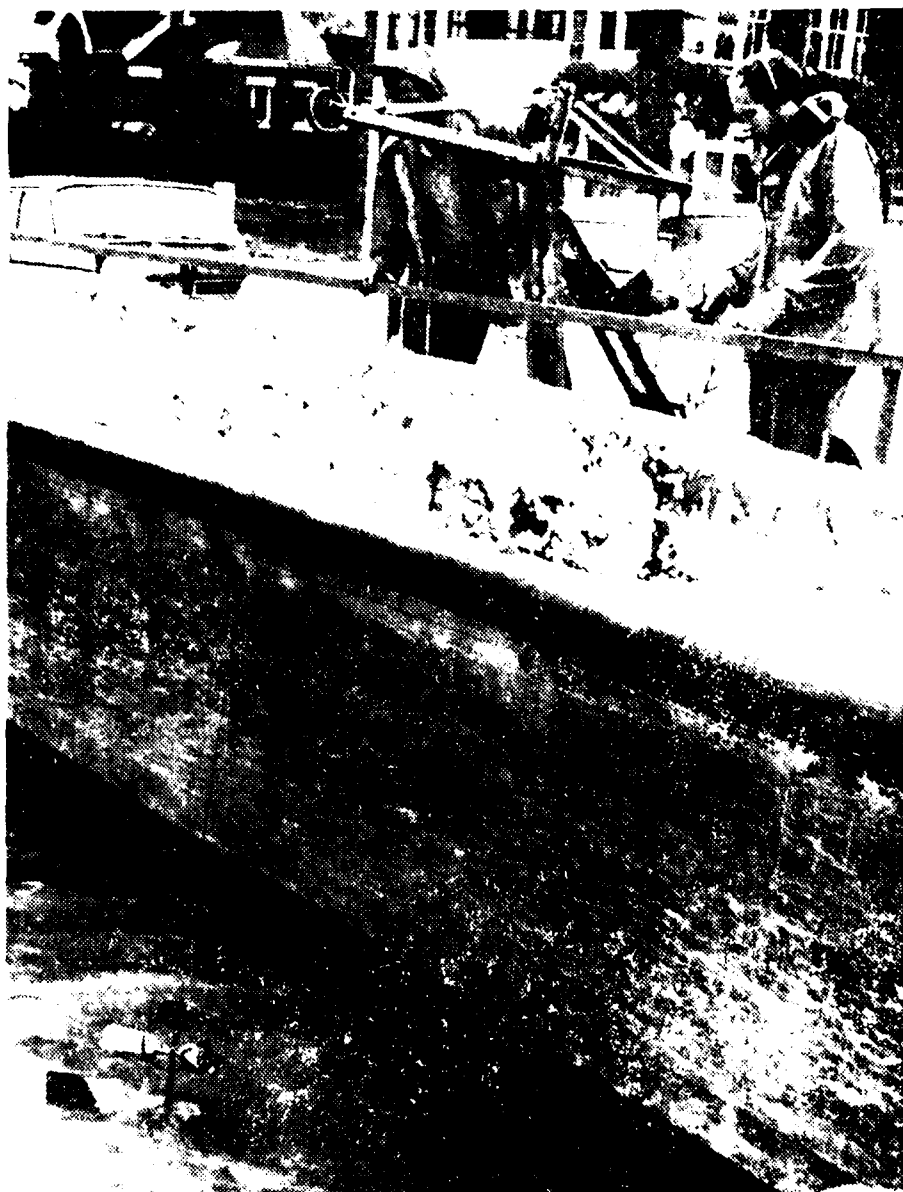
Velocity Readings

Two U. S. geological surveyors, Joseph Robideau (left) and Mark Hays, lower a velocity meter which measures the speed of water into swollen Nine Mile Creek, off the Route 1 bridge in downtown Camillus yesterday, fishing for more facts in the creek whose flooding banks have

closed the Camillus-Carlisle road in an estimated \$150,000 of damage to the area's homes and businesses. The surveyors, from the Marcellus area, are on this normally quiet stream. Readings taken yesterday showed the water was moving at

Robideau and Mark Have while working at the bridge in front of the Cutlery in Camillus said the stream, which "normally moves at 300 cubic feet per second, is now moving at about 1,700 cubic feet per second."

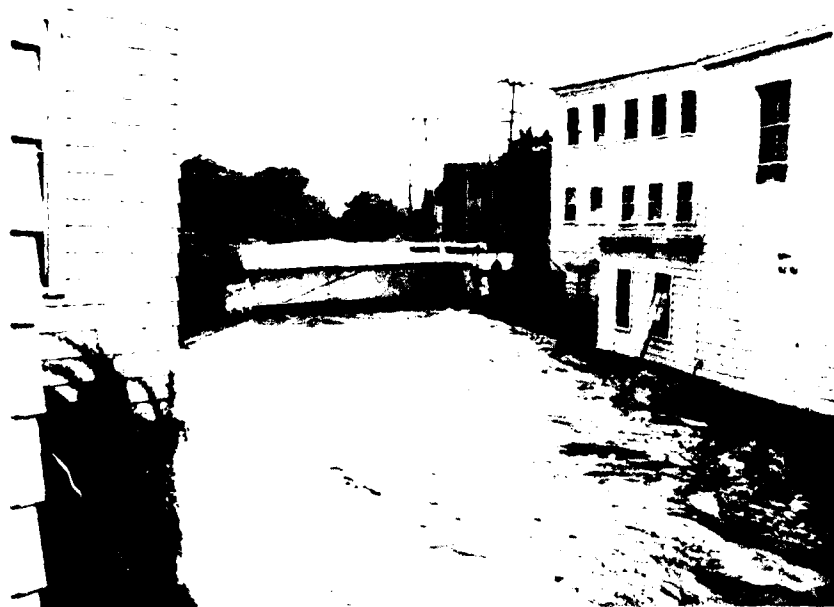
FIGURE 16 - Receding waters of the July, 1974 flood barely clear the bottom of the Genesee Street bridge in Camillus (stream mile 7.2). Building at right is part of the Camillus Cutlery Company.

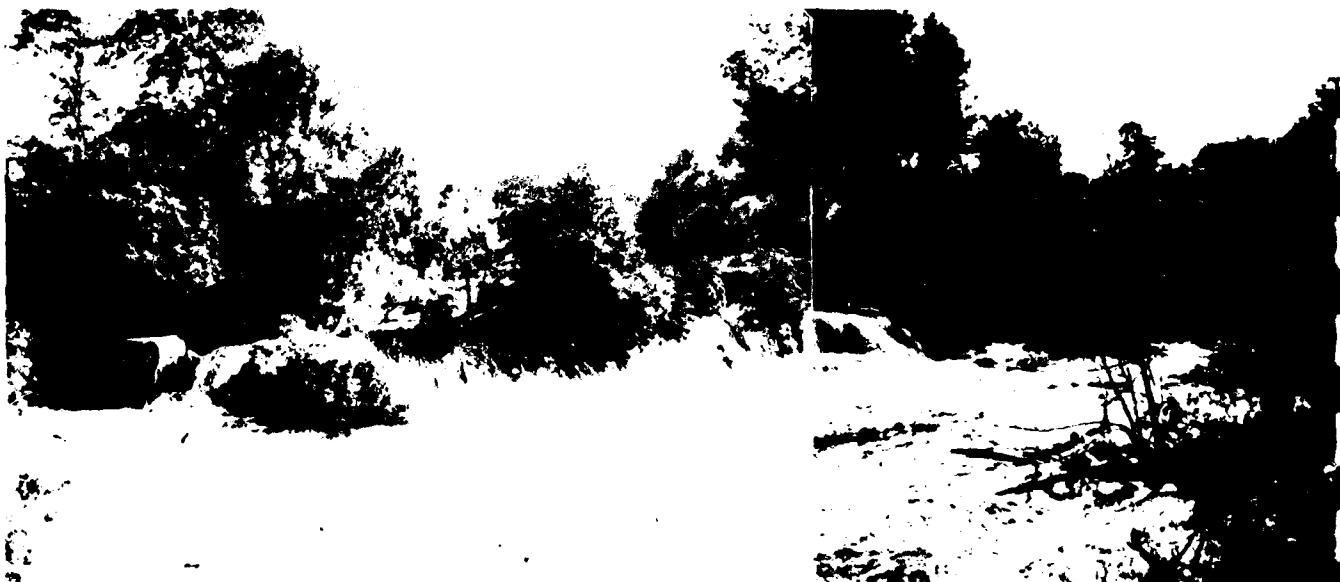
FIGURE 17 - Debris carrying waters of the July, 1974 flood pour over dam 1 (stream mile 3.83) located just upstream of Warners Road bridge at Amboy in Camillus.

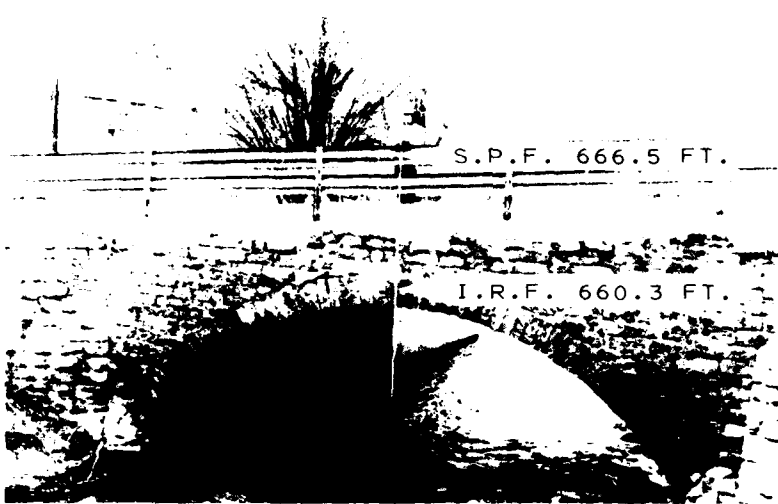
FIGURE 18 - Future flood heights at upstream side of Seneca Turnpike bridge (stream mile 12.84) in Marcellus. Photo taken April, 1975.

Photographs, Future Flood Heights - The anticipated water levels of the Intermediate Regional and Standard Project Floods at various locations along Ninemile Creek are illustrated on the photographs on the following pages.

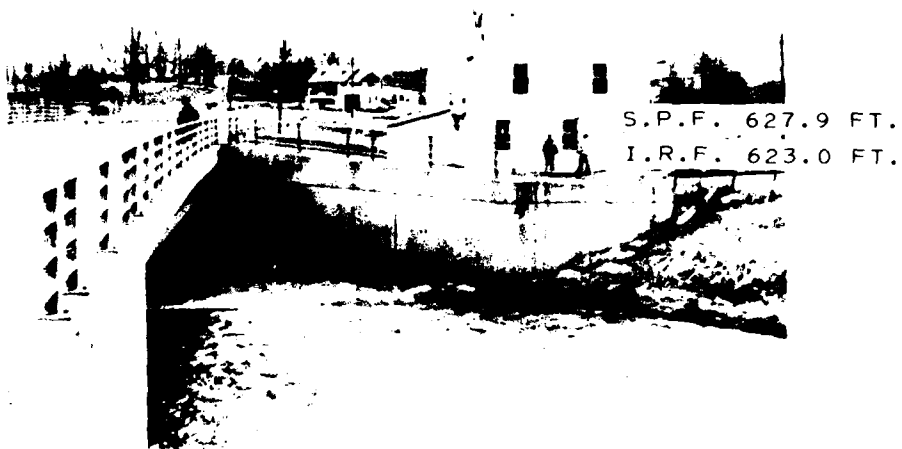
FIGURE 19 - Future flood heights at upstream side of Route 174 bridge (stream mile 12.08) in Marcellus. Photo taken April, 1975.

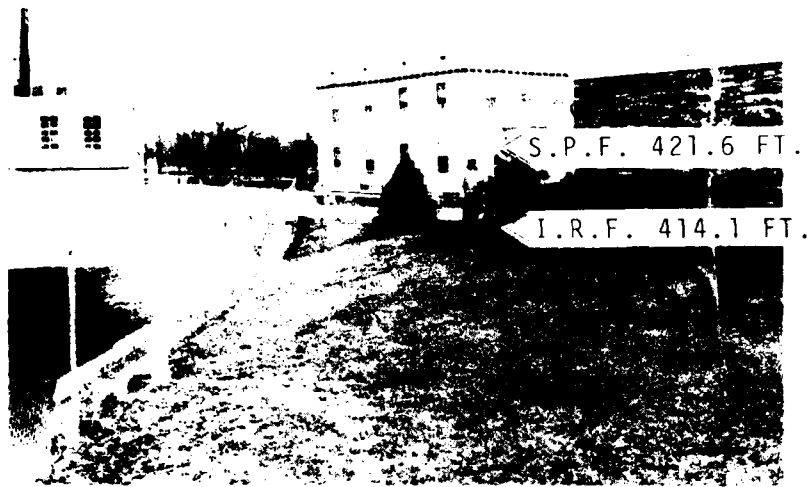
FIGURE 22 - Future flood heights on upstream side of Genesee Street (Route 5) in Camillus. Brick building in right foreground is Camillus Animal Clinic, 31 East Genesee Street.

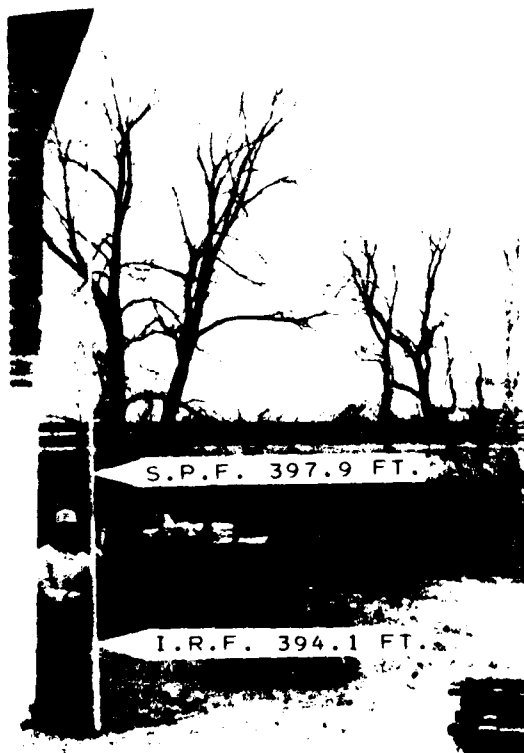
FIGURE 25 - Future flood heights in back of Robert D. Spence Plumbing Supplies building located at corner of Warners Road and Airport Road in Camillus. Warners Road bridge (stream mile 3.82) is 50 feet upstream in the background. Photo taken April, 1975.

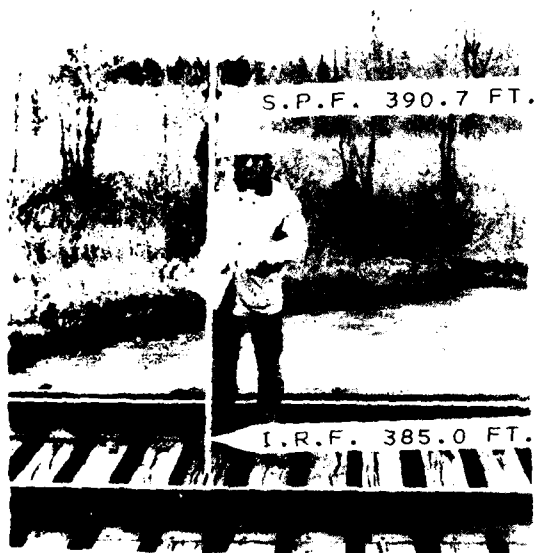
FIGURE 26 - Future flood heights at Penn Central Transportation Co. bridge over Ninemile Creek (stream mile 2.52) near intersection of Van Buren, Lakeland and Airport Roads in Camillus. Photo taken April, 1975.
